HUNGERFORD TOWN COUNCIL

MINUTES of the **Recreation, Amenities and War Memorials Committee** meeting held on Monday 15th January 2024 at 7.00pm, in the Library, Hungerford.

Health and Safety report for Hungerford War Memorial (Bridge Street)

Inspection Checklist for St Lawrence's church yard

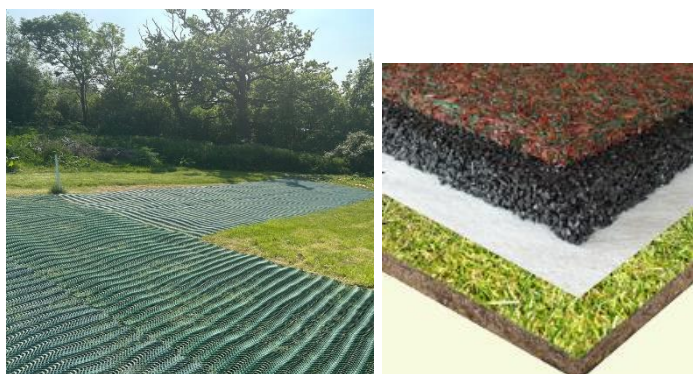
Contractor	Price
A	To go under the yellow bench to protect the grass. Grassmats Ltd (See image below) Grass Reinforcement Mesh Medium (13mm) - 2m x 20m - Grassmats –	£1,000
B	To reinforce the crumbling bank near the new ramps Infinity Playgrounds (see image below) Price to supply and install 11m ² of Bonded rubber mulch in autumn blend or green on a weed membrane, with the edges dug into the ground for a smooth transition between rubber and soil/grassed areas. Supply and install soil and seed around edges to dress.	£1,279.50
C

Skatepark ground improvement – Cllr Fyfe has previously provided a presentation on options available and recommended Grass Reinforcement Mesh. Cllrs agreed Grass Reinforcement Mesh option should be sourced as it was agreed it would provide greater protection than the bonded rubber option as it allowed grass to grow. Cllr Simpson felt it would provide greater longevity and had no experience of rubber bonding but it was noted that it was used in Victoria Park Skatepark.

Cllrs agreed to opt for Grass Reinforcement Mesh an updated quote.

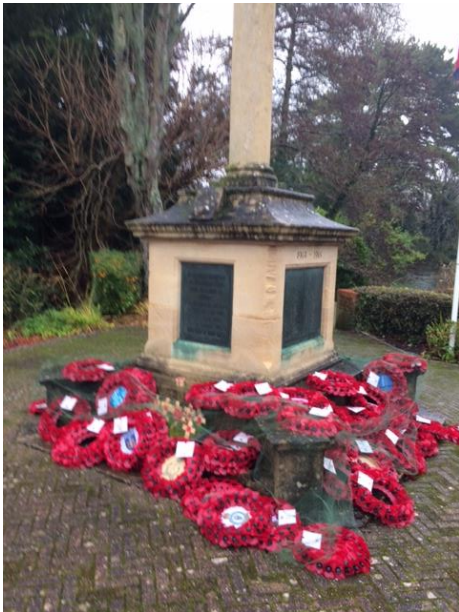
Memorial-would benefit from cleaning of the steps and canopy above the name plates. **Still outstanding but plate areas seem to be recently cleaned see pic below.**

Half a job!

Cllrs discussed the cleaning of the memorial and concluded that someone had tried to clean it and used the wrong materials (it was noted that chemicals cannot be used).

Action: Cllrs proposed that the Office obtains quotes for a Specialist Clean Office Contact War Memorial Commission to seek advice on how to clean it properly Explore whether we could apply for a Grant from them or any other organisation?

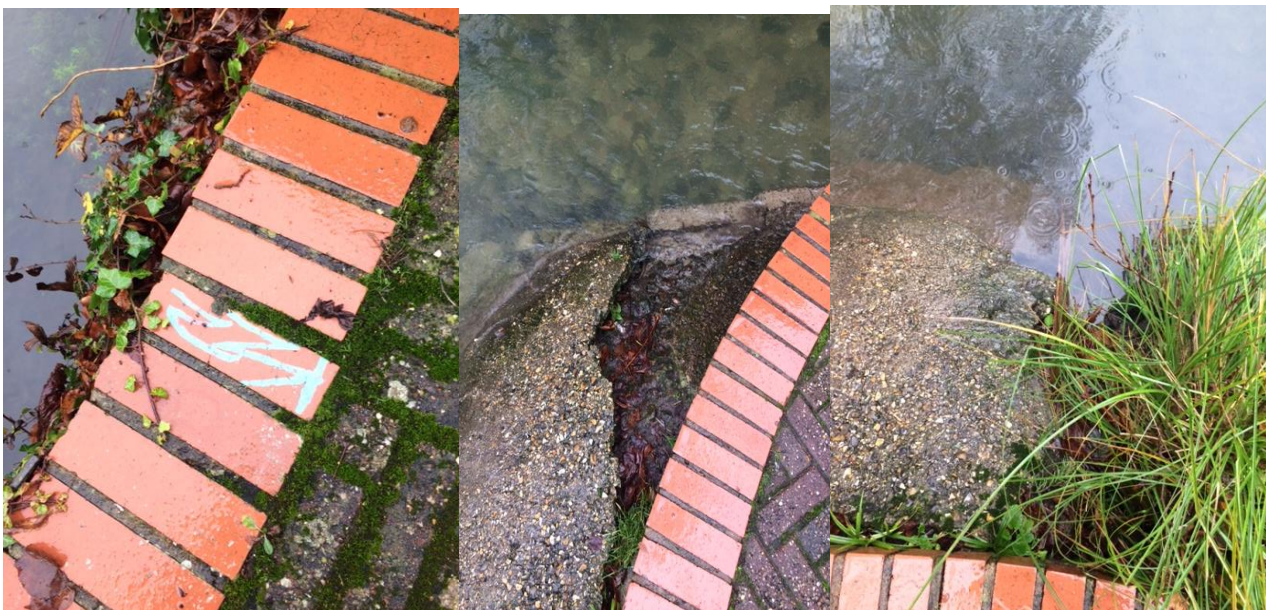
River seating area banking- the concrete buttress at the river confluence is coming apart. Whilst this does not present a H&S issue it would be better to address it at the same time the paving is sorted. **Same condition but has not worsened. The brick edging appears to have been tagged (See 2023 pics)**

War Memorial - Councillors discussed the memorial and noted that the same issues were reported as in previous years and remained outstanding. Overall, the Bridge Street War Memorial presented as well cared for but identified moss remained a significant slip/trip hazard. It was also agreed that the steps and canopy needed to be cleaned. The block paving remains uneven and requires attention along with the concrete buttress in the river. It was agreed that a budget was required.

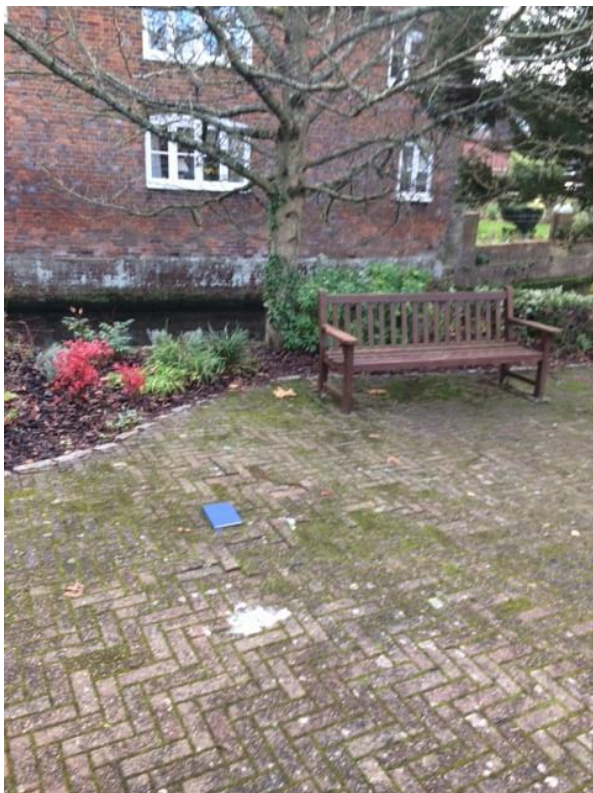
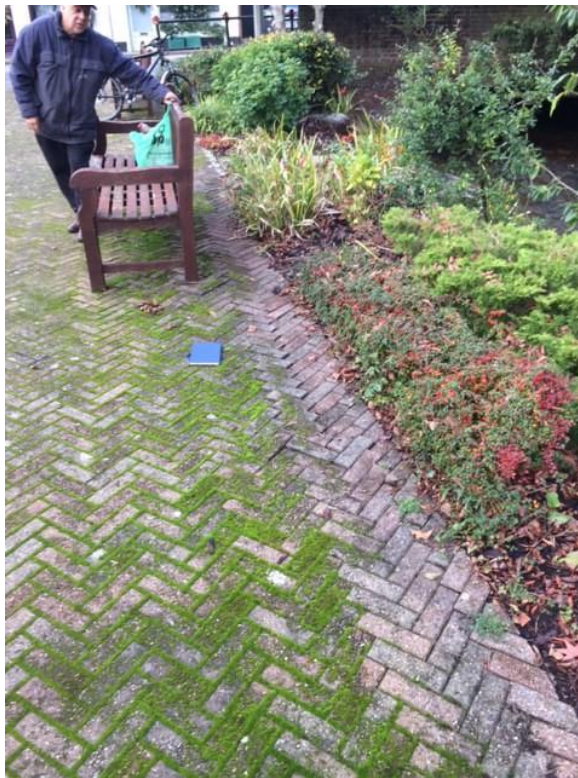
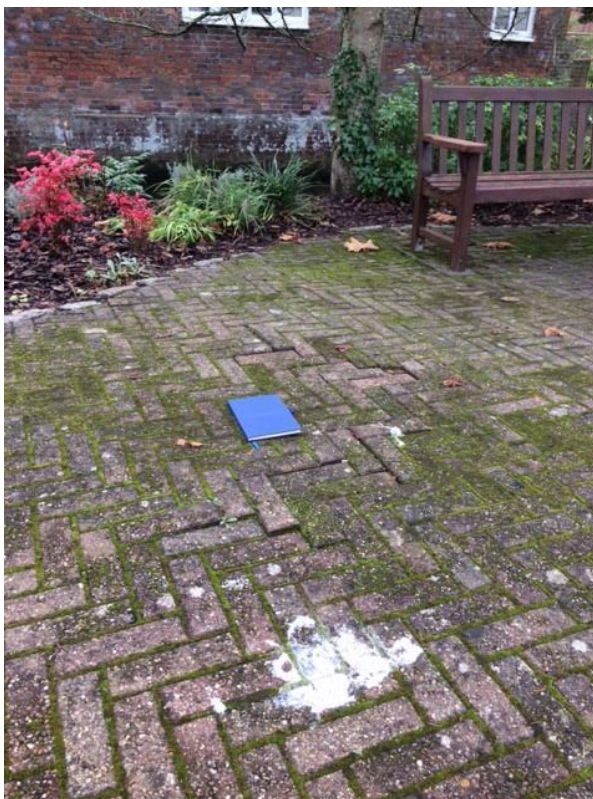
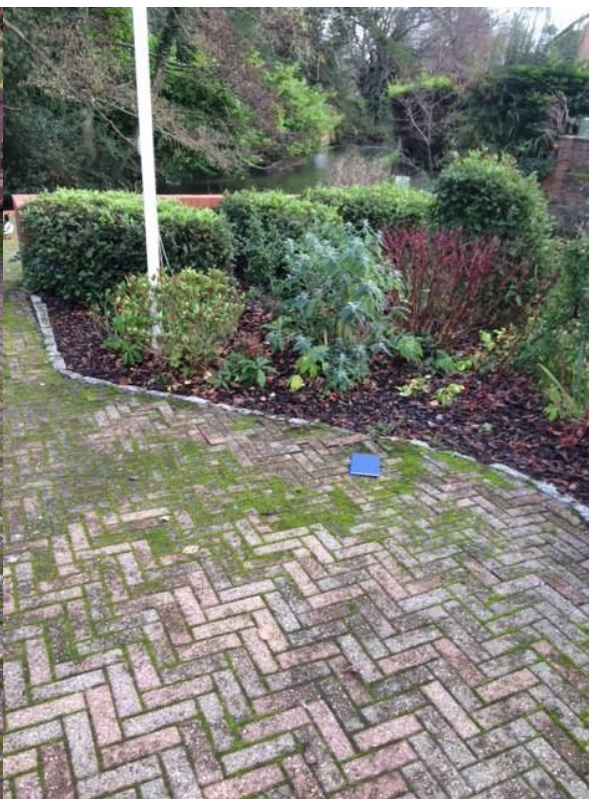
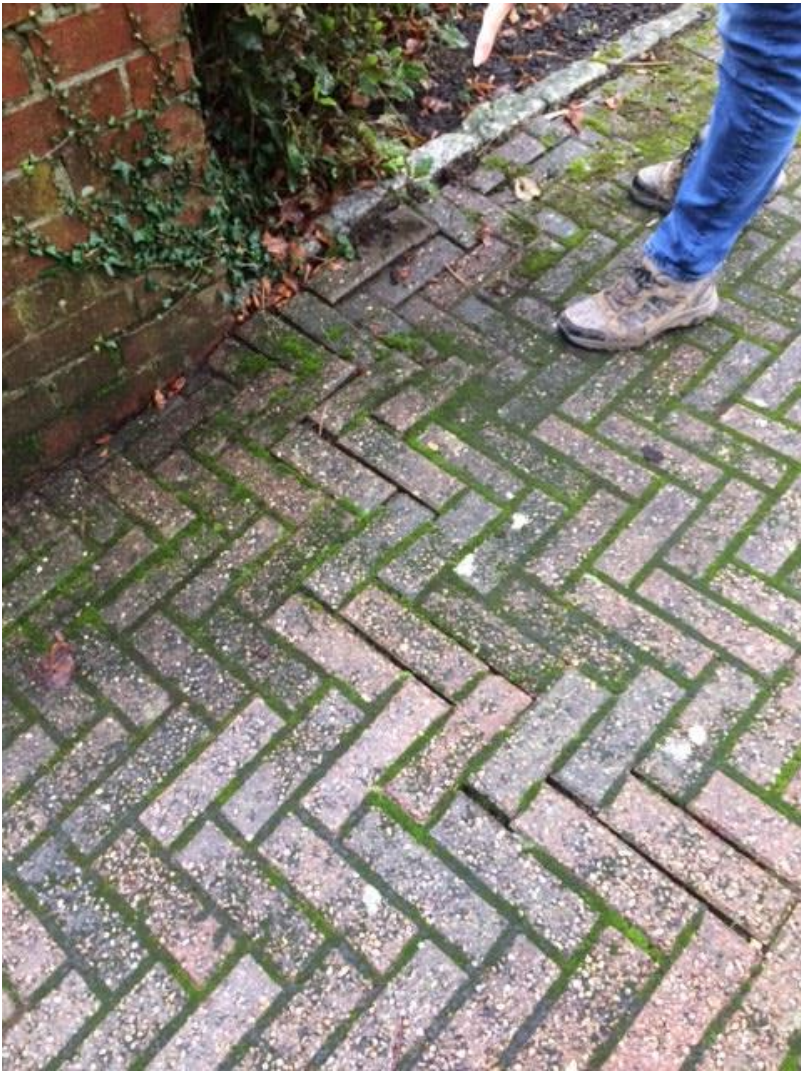
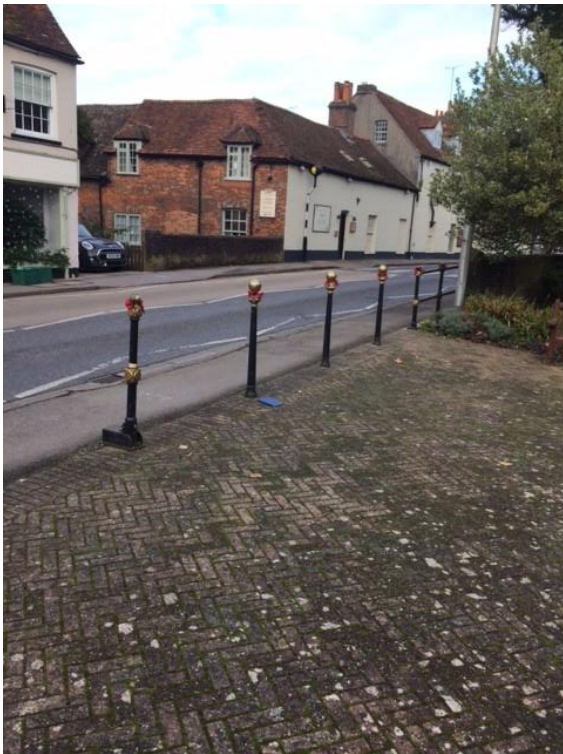
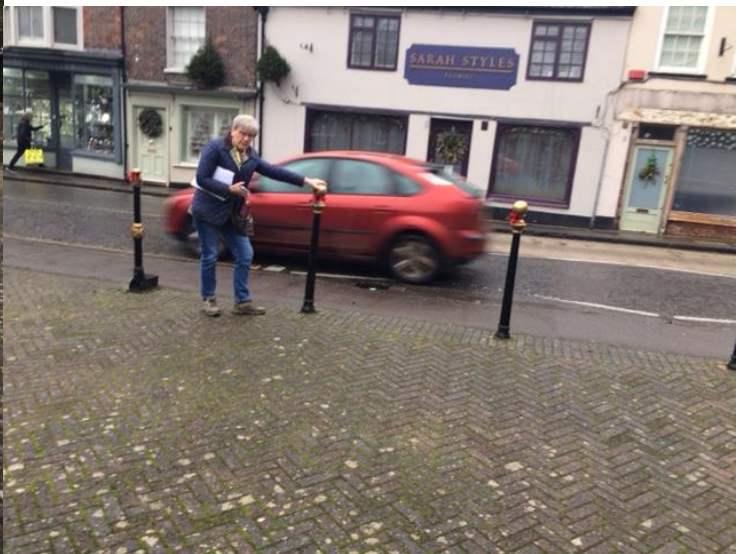
Block paving faults (note blue book as indicator)

Entrance Bollards – The 3 one from the left facing the memorial is loose and **needs to be re secured Still loose see pics below.**

Block paving – Paving is uneven and lifting in three areas of the main site (listed below 7 pics) and sinking in one area. The slope leading down to the seating area next to the river has lifting blocks at the transition point. **Still in same condition has not worsened significantly.**

This has been previously noted but will only deteriorate if not addressed.

Suggestion regarding moss is to ask WBC if a small ride on street cleaner can be sent to Hungerford to scrub and vacuum block paving at memorial to remove moss. It is not advisable to use a pressure washer as this will blast out the locking sand of the blocks and make situation worse. Also the runoff from this would enter the chalk stream.

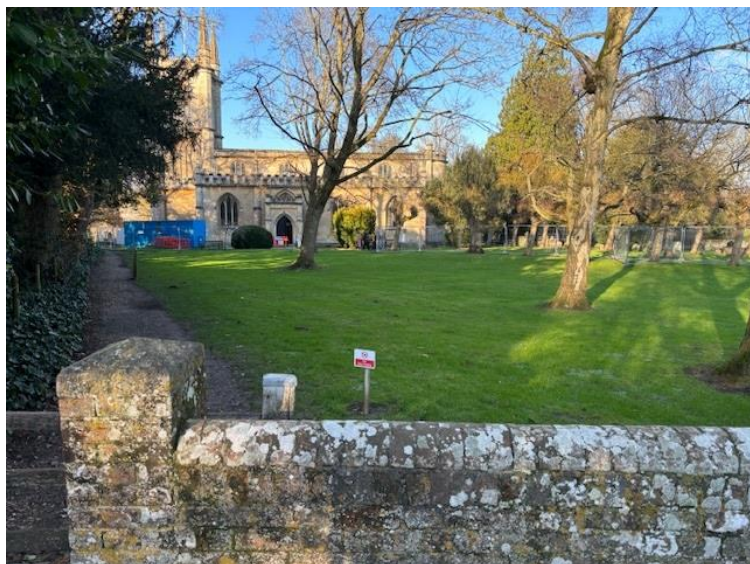
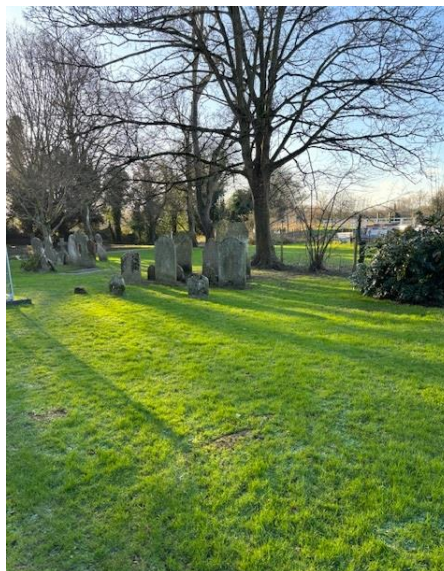
Overall general appearance / impression is looked after and well cared for. Boundary wall and clapper gate in good order:

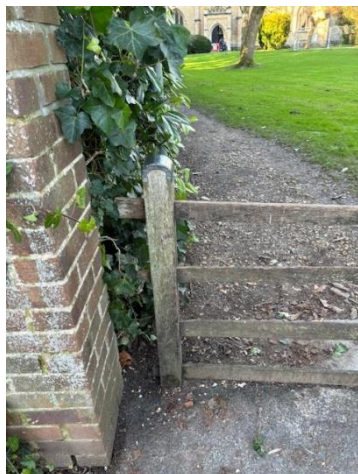
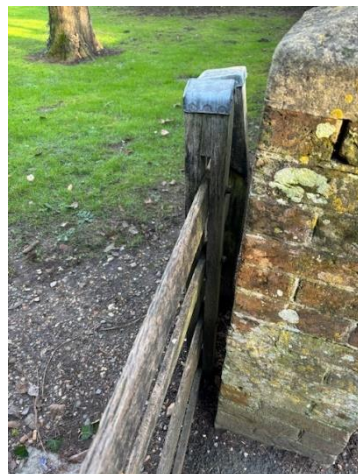
Clapper gate – a very rare feature and in good order:

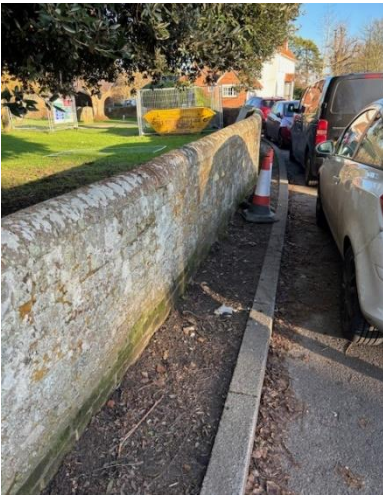
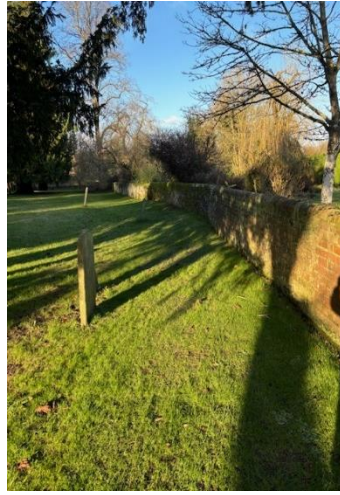
Walls in good condition:

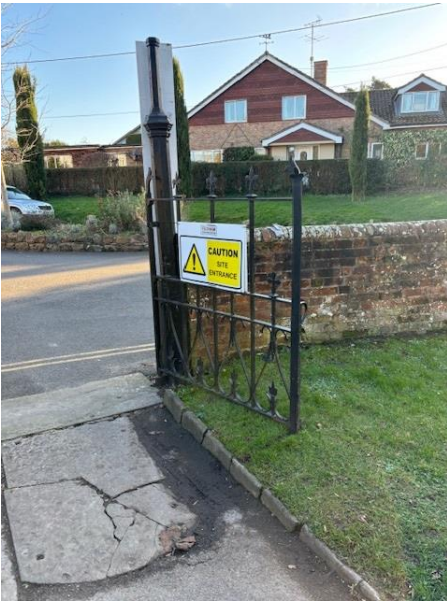
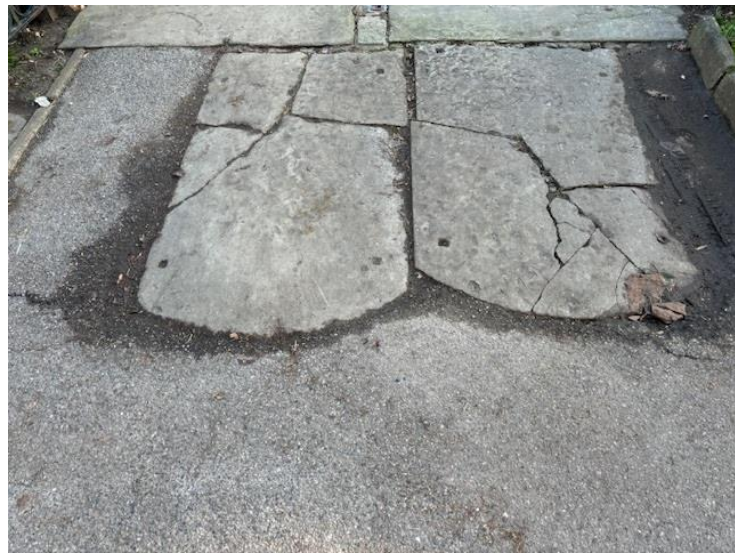
St Saviours Cemetery noted by Councillors to be generally in good repair but concern raised regarding the two slabs (old gravestones) at the entrance of the St Lawrence's graveyard, which are shattered and fractured into multiple pieces and are a trip hazard. Some gravestones are precarious but wobble test are carried out and those at risk are laid flat. It was identified that one of the benches needs to be urgently removed (broken feet) and could be replaced with the one that is currently situated in another part of the cemetery that has become 'slimy' from being under the trees. It was agreed that should anyone wishing to donate a bench in Hungerford, St Lawrences should be considered the first option.

Areas	Questions	Comments	Further action required (please tick)
Site	Are fences secure & complete?	YES	
	Are gates in working order?	YES. However, main gate pathway (south) entrance slabs (appear to be old gravestones) left hand stone smashed and sunken with significant step to tarmac on northern edge. Trip hazard.	✓
	Are pathways undamaged & free from obstructions?	YES	
	Is the site free of litter and animal fouling?	YES. Obviously, significantly impacted by ongoing building works, with some general detritus.	
Ancillary items	Are seats/benches in good condition?	No. All seats need cleaning and treating. Bench adjacent to the path (midway along on the grass front eastern area) has rotted legs that have completely detached from the base mounts and could topple if sat on. The last bench before the Canal entrance requires cleaning as it is completely covered in green slime. The base also has a raised edge, presenting a trip hazard.	✓

Entrance gate – trip hazard (on left as enter; RH side of photo):

Action: Cllr Coulthurst agreed to contact St Lawrence's Vicar to discuss what action can be taken with the slabs and the necessary process involved in repairing the two damaged slabs.

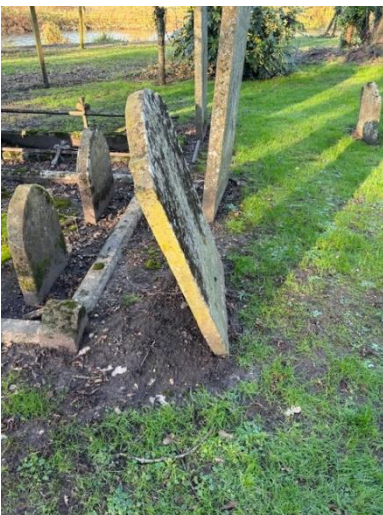
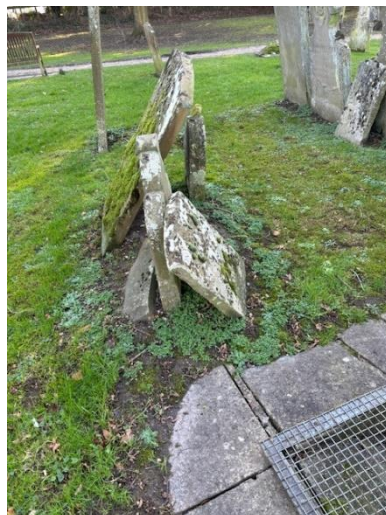
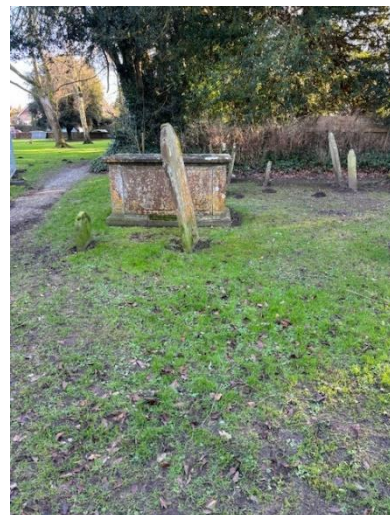
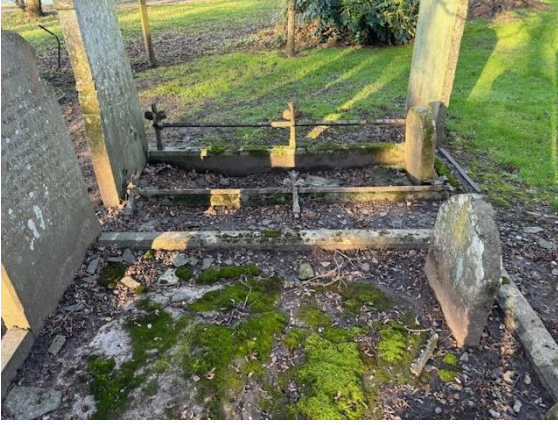
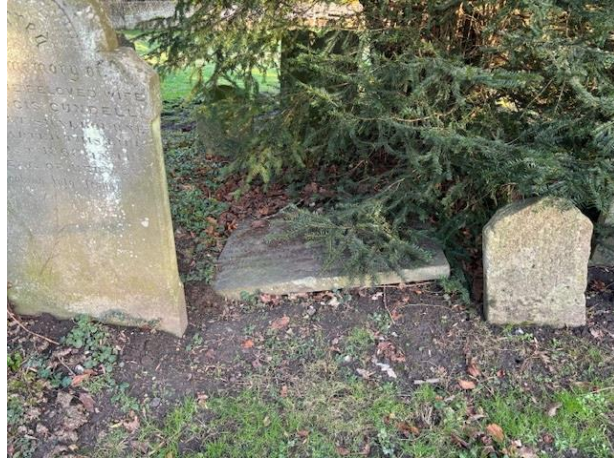
Leaning gravestones / broken tomb surrounds:

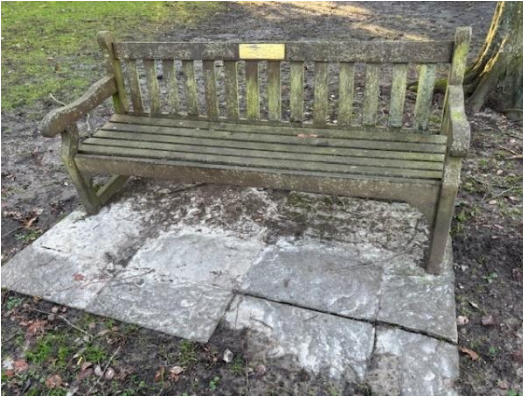
Benches generally not in good condition and some dangerously decayed/unusable:
Trip hazard – see RH side of photo

Town Clerk to instruct maintenance man to remove the bench and replace it with the alternative bench. Office to distribute Bench Cleaning Schedule to Councillors and the option of using money in the Contractors budget to improve the overall condition of the benches was proposed. Office to contact maintenance man to remove fridge.

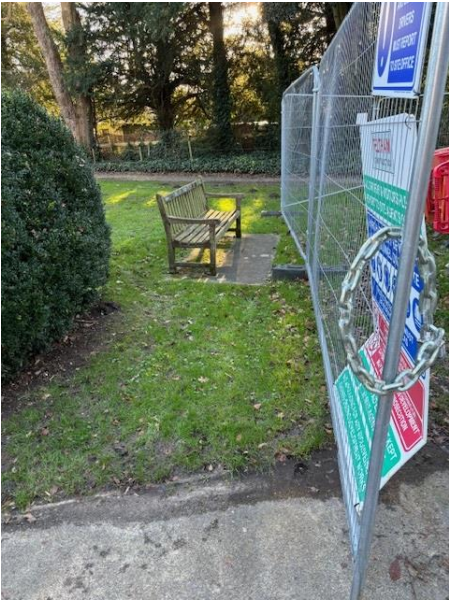
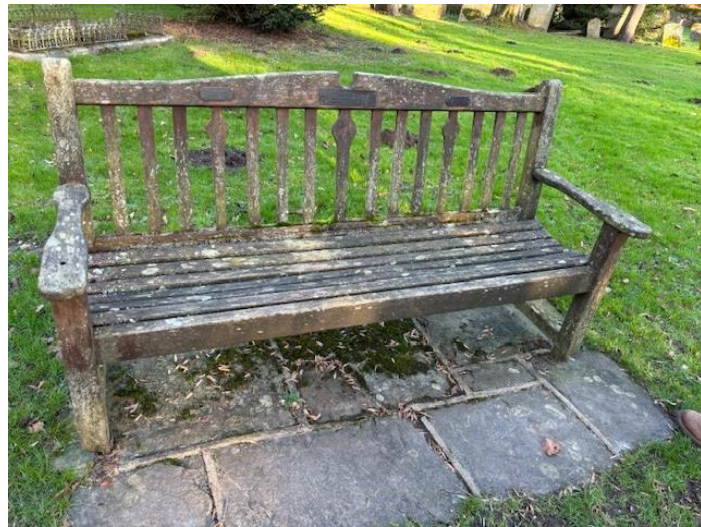
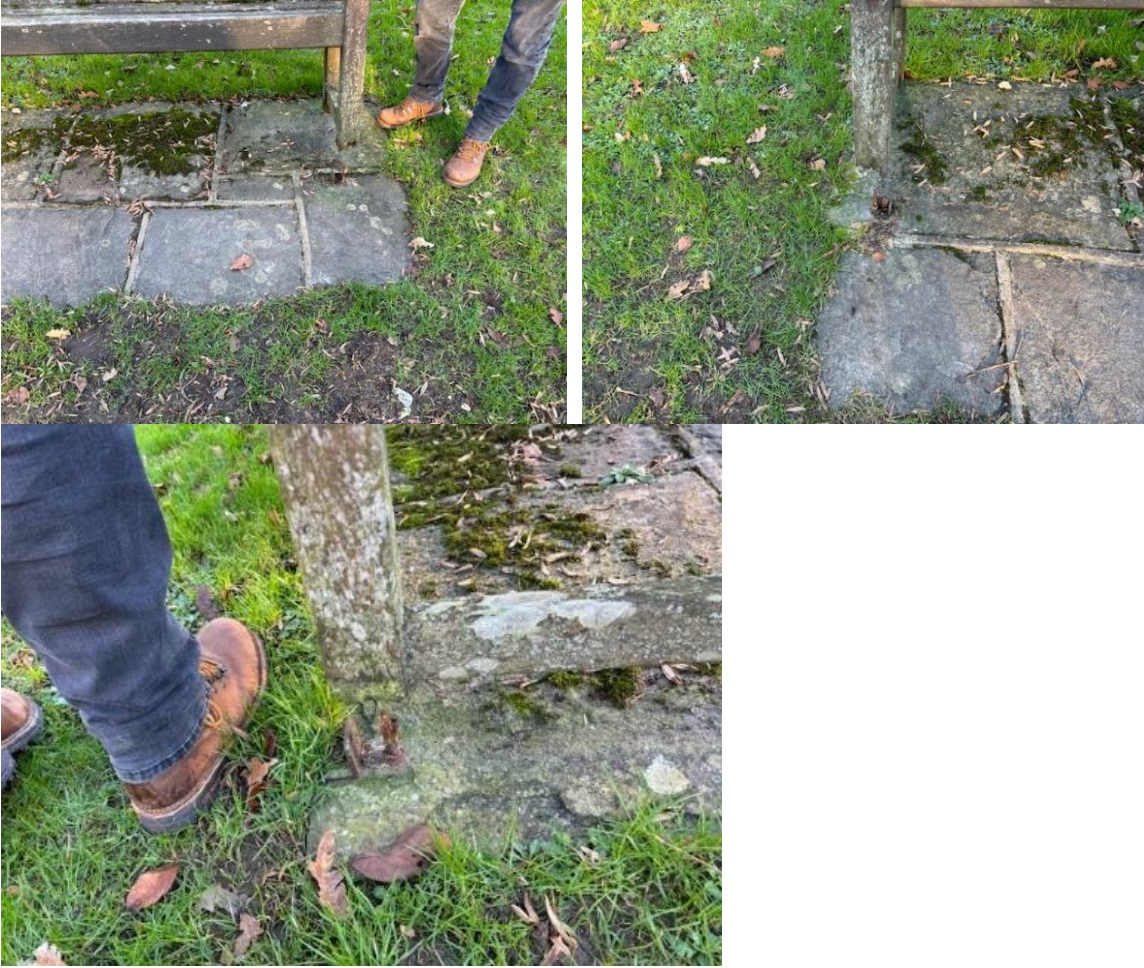
Slime and foot-rot!

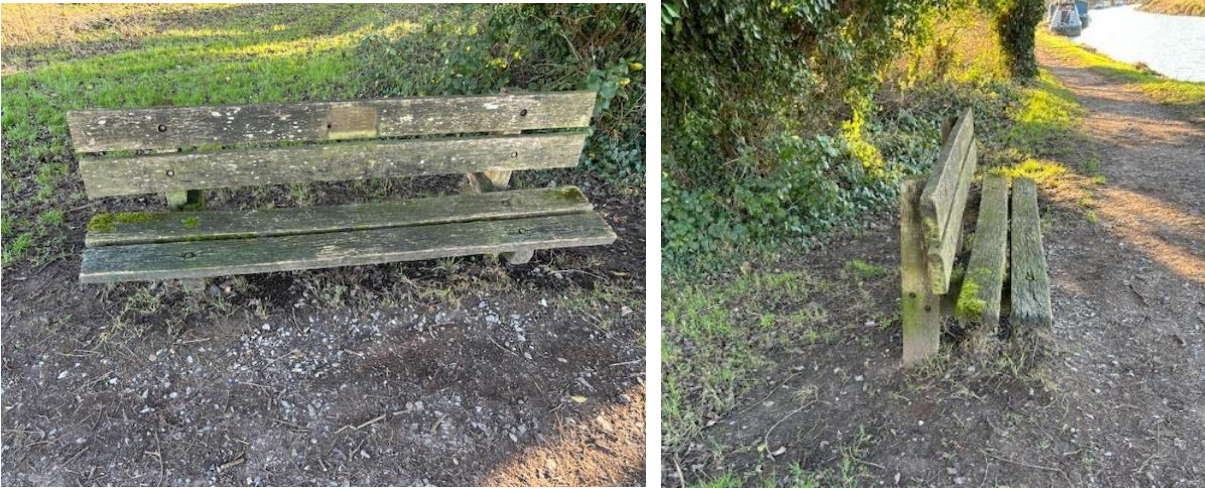
There is also a bench just outside the entrance on the canal bank that is completely unusable due to leaning so close to the ground.	
	Are litter bins secure and emptied?	No litter bins on site.	
Surface	IS the grass cut regularly	YES	
	Is the site well drained?	YES	
	Is the grass in good condition?	YES but could use moss treatment at appropriate time of the year	✓
Other	Are paths cleared of leaves?	YES	
	Evidence for the last memorial inspection programme		
	Seats	See comments above	✓
	Gravestones / graves	Several gravestones are leaning at considerable / precarious angle. They are solid but will continue lean at ever increasing angles. One gravestone partially hidden in a yew tree stand towards eastern side of cemetery has completely fallen over. Also, some tombs are showing considerable wear (e.g. on wrought iron surrounds).	✓
	Boundary walls should be checked	Good condition	
	Maintenance programme for wall

Canel bench – not ours?

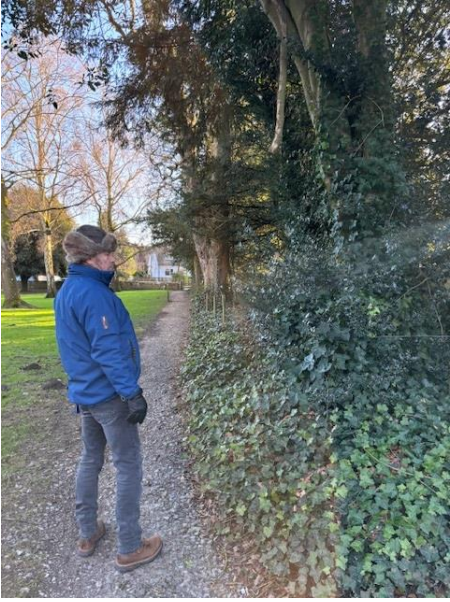
Identify any rabbit warrens, fox holes and badger sets as they can create tunnels creating holes.	None seen	
	Trees/Branches	Main avenue pollarded. Looks OK but not possible to judge if all the trees are alive. As per last year, down the west path is a tree where the ivy has been killed by cutting a gap. The upper 10m of dead ivy should be removed. Coming loose.	✓

Trees generally OK – but some hanging ivy, also noted last year:
